**INFORMATION FROM THE INVESTIGATING OFFICERS REPORT OF MOTOR VEHICLE ACCIDENT**

Case Number: **20-11160**  
 Date of Acc: **08/03/20**  
 Time of Acc: **15:03** Hrs.  
 Name of Agency: **MAQUOKETA POLICE DEPARTMENT**  
 Officer: **OFFICER JAYSON HEIAR**  
 Badge #: **58**  
 Report Date: **08/03/2020**  
 Officer Notified: **15:03** Hrs.  
 Officer Arrived: **15:09** Hrs.  
 Scene Investigated: **YES**

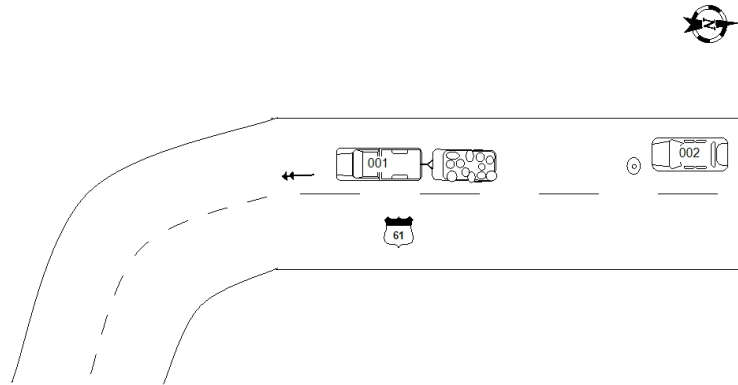
Unit 001 and Unit 002 were traveling southbound on Hwy 61 near the 157mm, when a tire from an unsecured load came off of the top of the trailer that was being towed by Unit 001, and struck the front and side of Unit 002 causing functional damage to Unit 002.
