**INFORMATION FROM THE INVESTIGATING OFFICERS REPORT OF MOTOR VEHICLE ACCIDENT**

Case Number: **2020-14306**  
 Date of Acc: **09/27/20**  
 Time of Acc: **14:48** Hrs.  
 Name of Agency: **MAQUOKETA POLICE DEPARTMENT**  
 Officer: **OFFICER JASON THOMSON**  
 Badge #: **61**  
 Report Date: **09/27/2020**  
 Officer Notified: **14:51** Hrs.  
 Officer Arrived: **16:05** Hrs.  
 Scene Investigated: **YES**

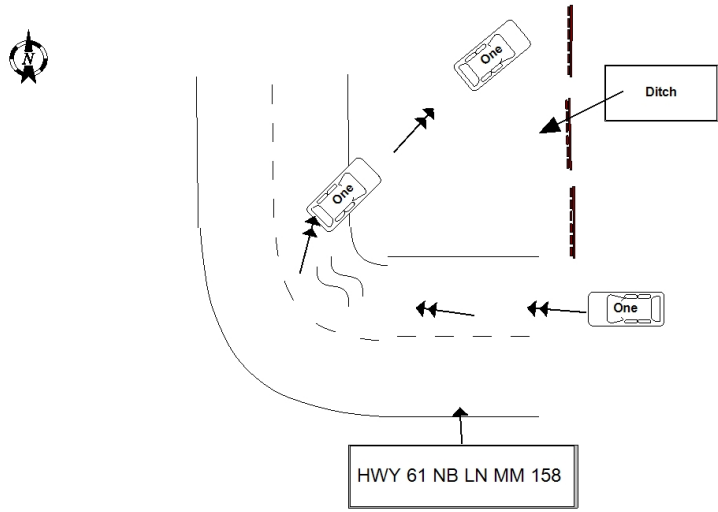
Diagram

Unit one was traveling north bound on highway 61 while driving through the curve on the road unit one lost control (hydroplane) due to the road being wet and went into the east ditch. Minor damage to unit one. No injuries were reported. No damage to the fence or ditch.
